# Selling Arguments *for* TIN ROOFING

*A review of the advantages of  
roofs of this type*

A textbook containing corrected tables for use in estimating, instructions for laying tin roofs, description of the manufacture of roofing tin, and a large amount of information useful to the practical man.

N. & G. Taylor Company, Philadelphia

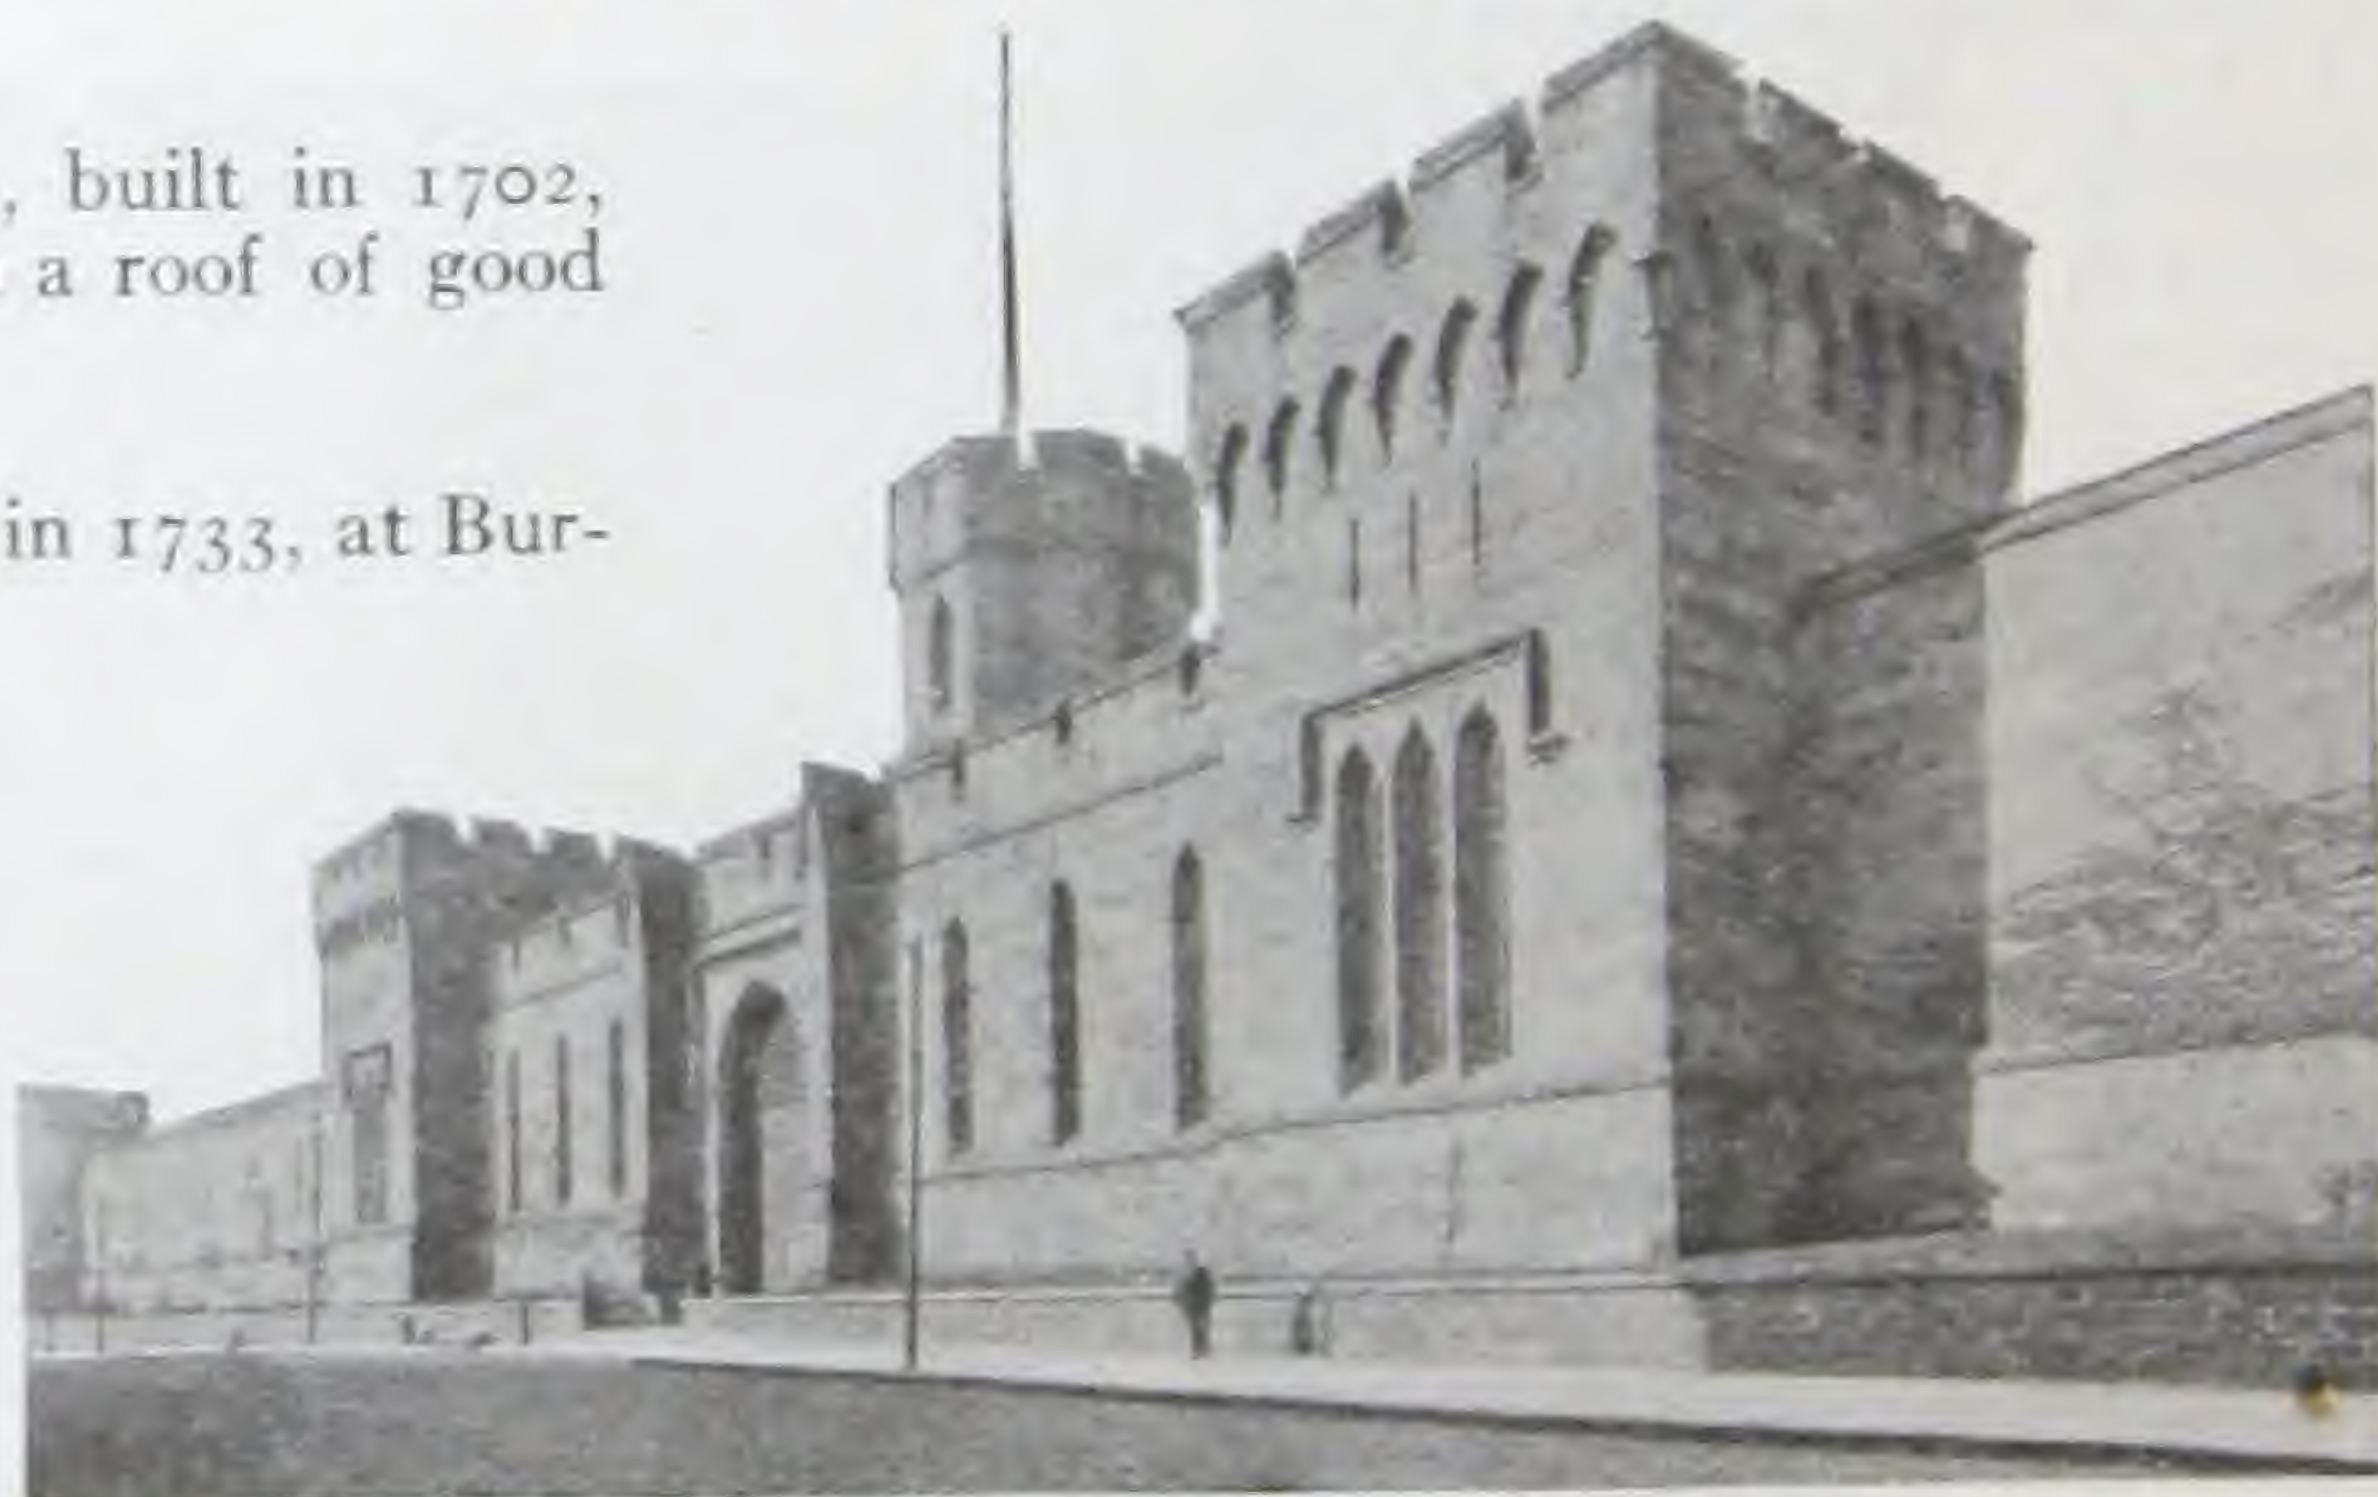
**5. DURABILITY:** Our tin is serving what will in all probability be a life sentence on the roofs of many of the buildings of the Eastern Penitentiary at Philadelphia. On the older buildings it has been giving good service for more than thirty years.

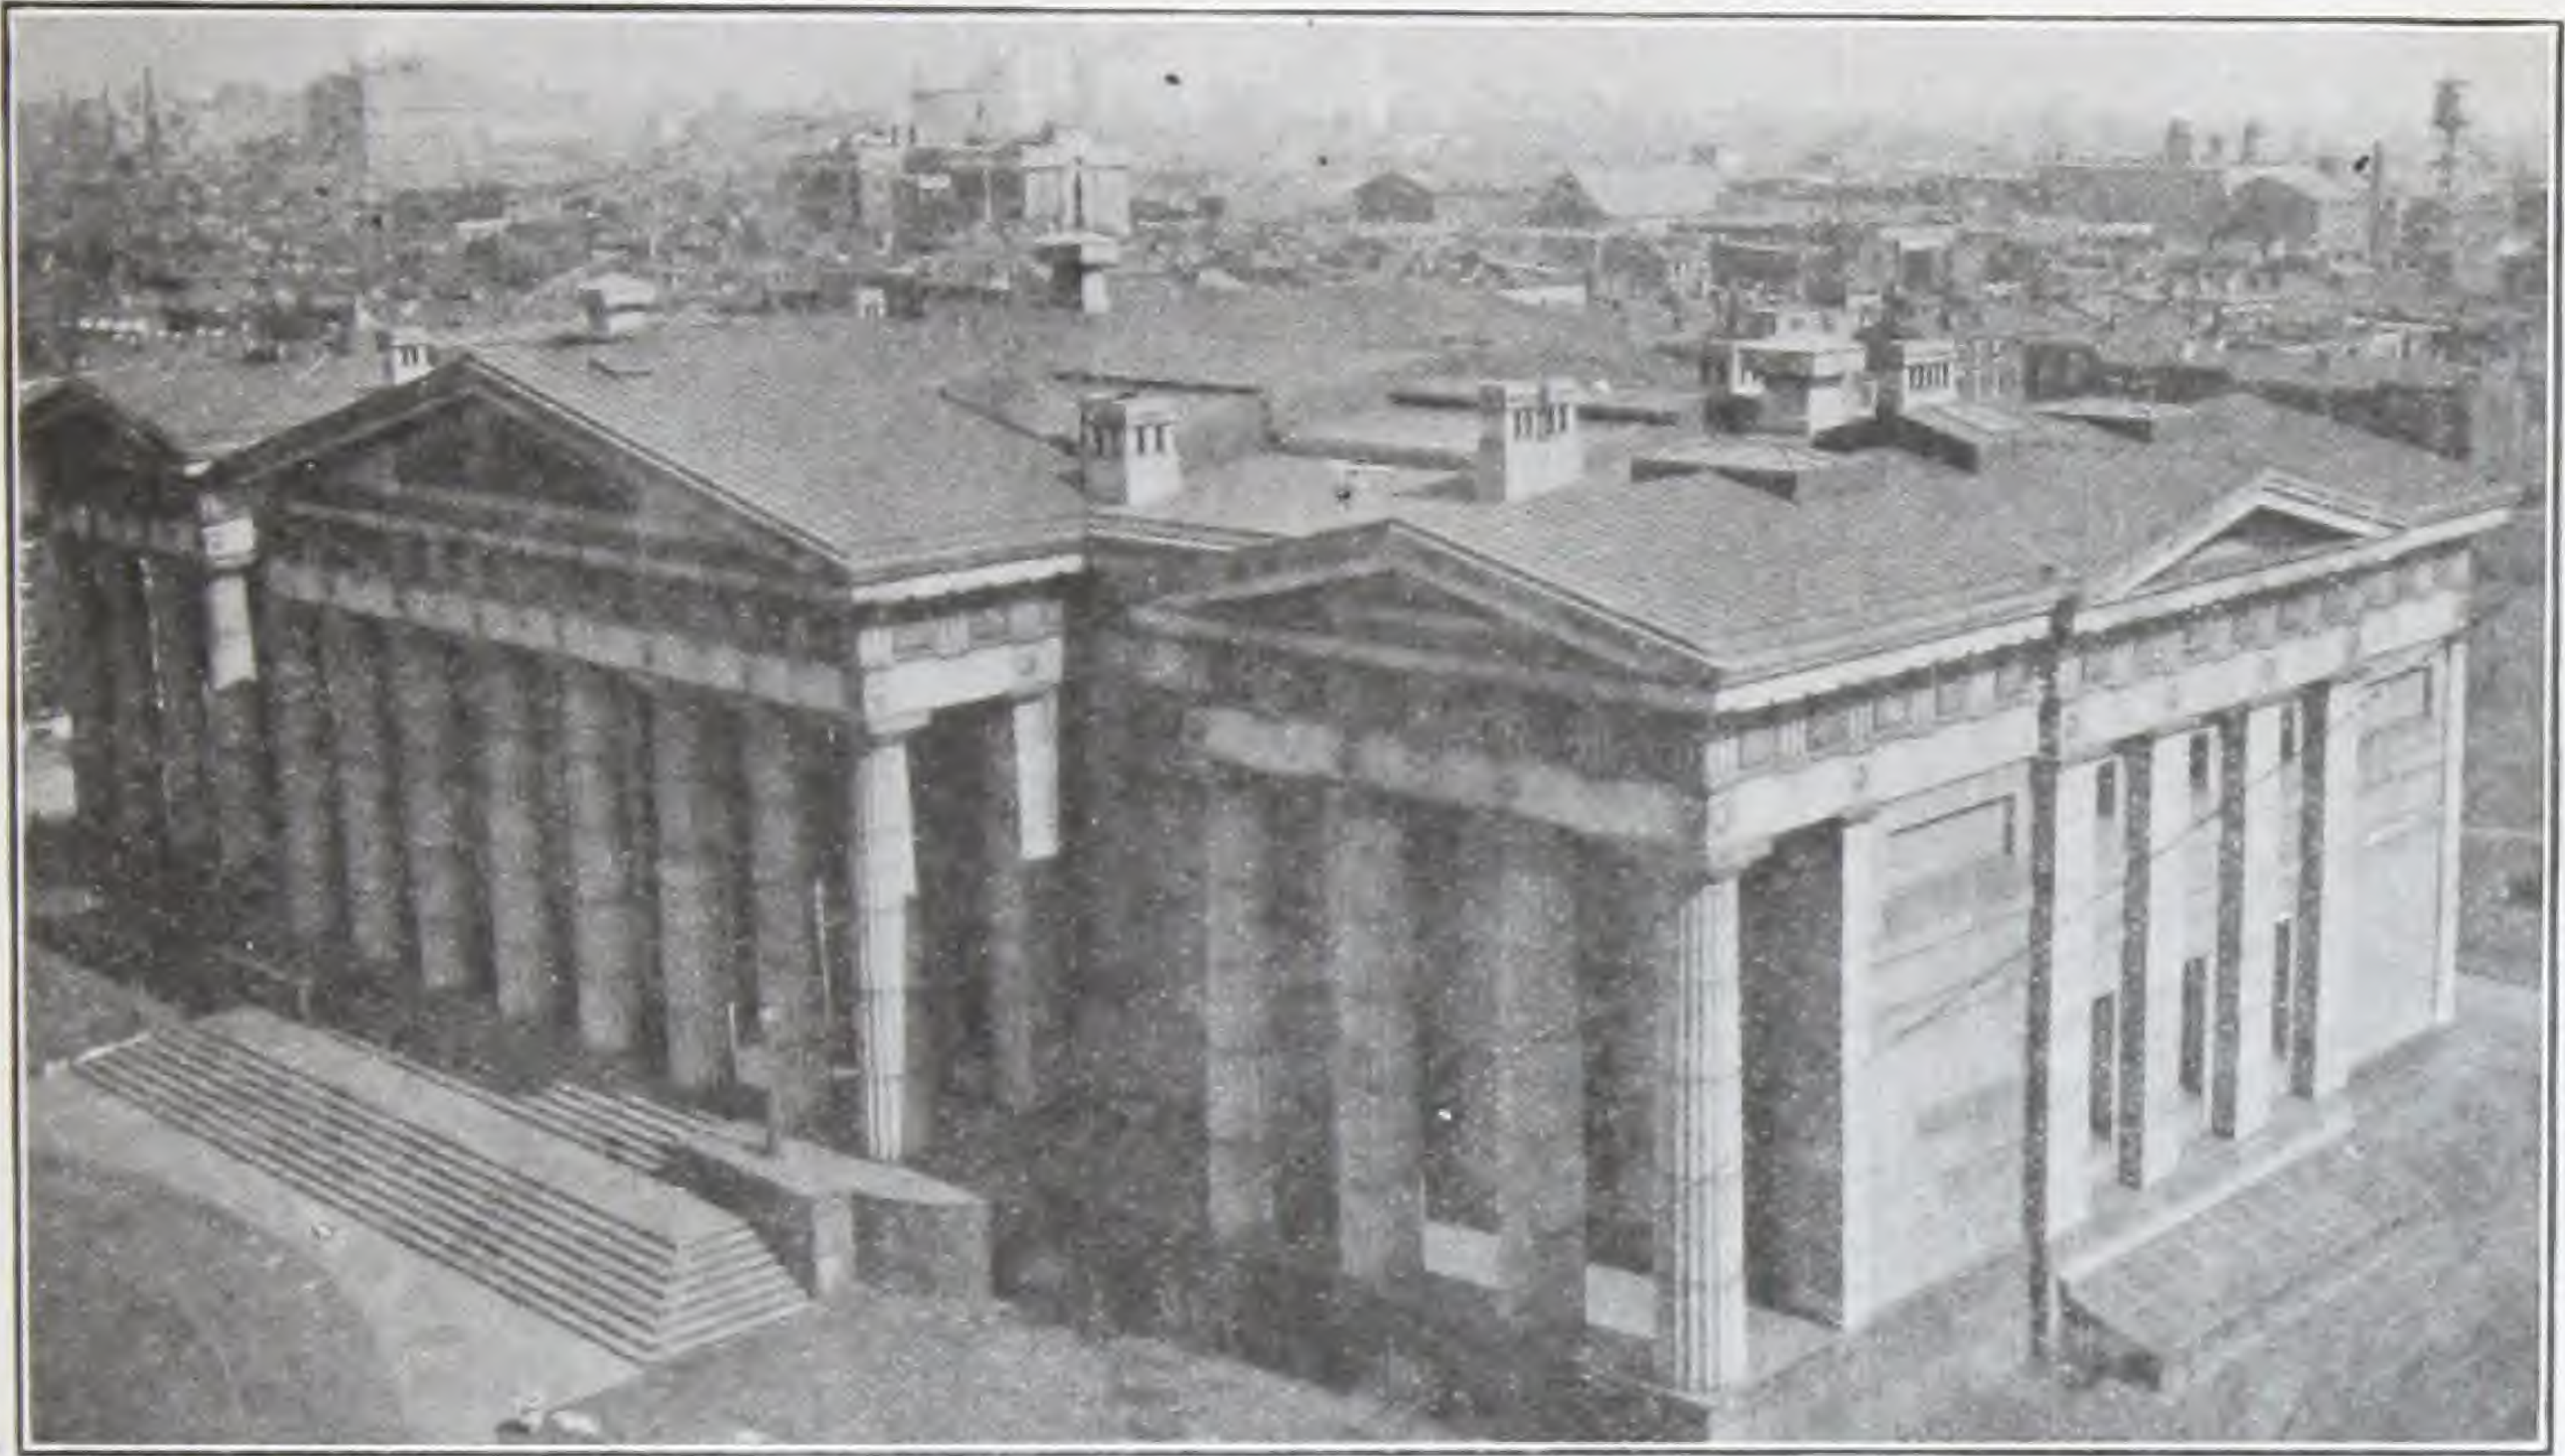
**7. DURABILITY:** The Ridgway Library building at Broad and Carpenter Streets, Philadelphia, was roofed with good tin in 1875 by William Obdyke & Sons. This roof has proved entirely satisfactory, and remains in good condition.

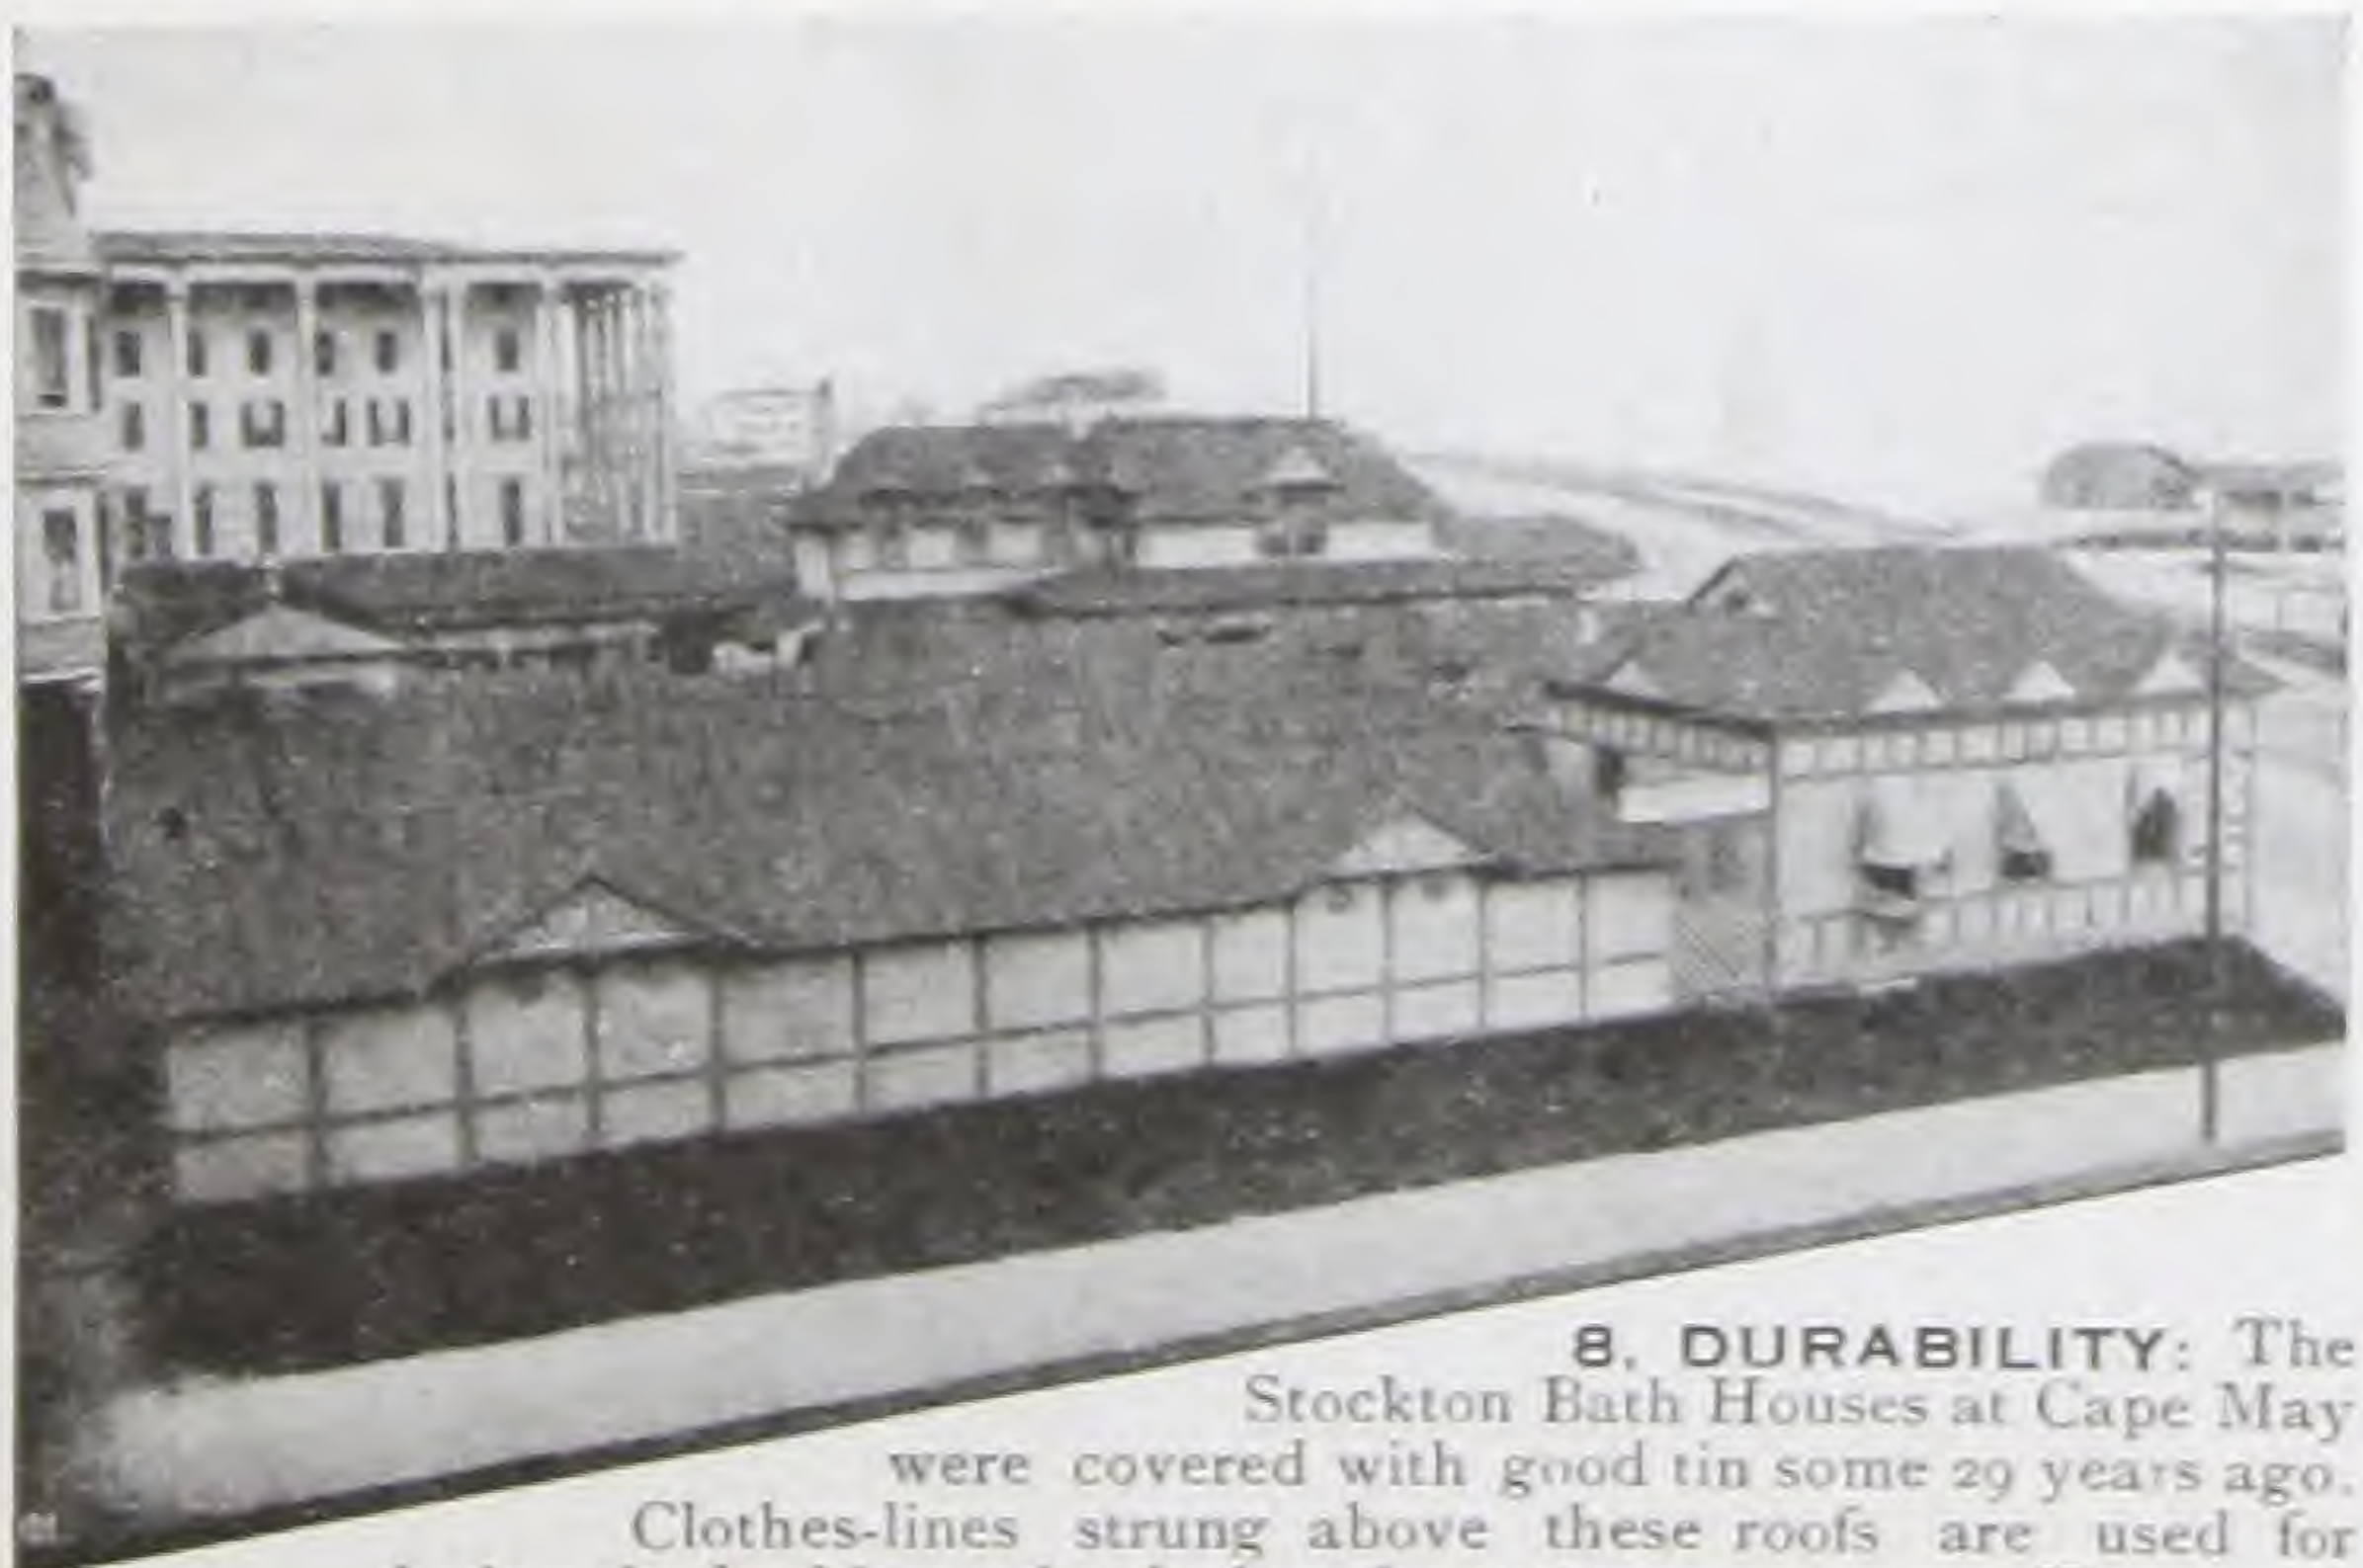
**8. DURABILITY:** The Stockton Bath Houses at Cape May were covered with good tin some 29 years ago. Clothes-lines strung above these roofs are used for drying the bathing suits during the summer season. The water from the suits drips upon the tin. In addition to this, the buildings are located directly upon the beach, within a stone's throw of the surf. These roofs have given entirely satisfactory service, and remain in excellent condition to-day.

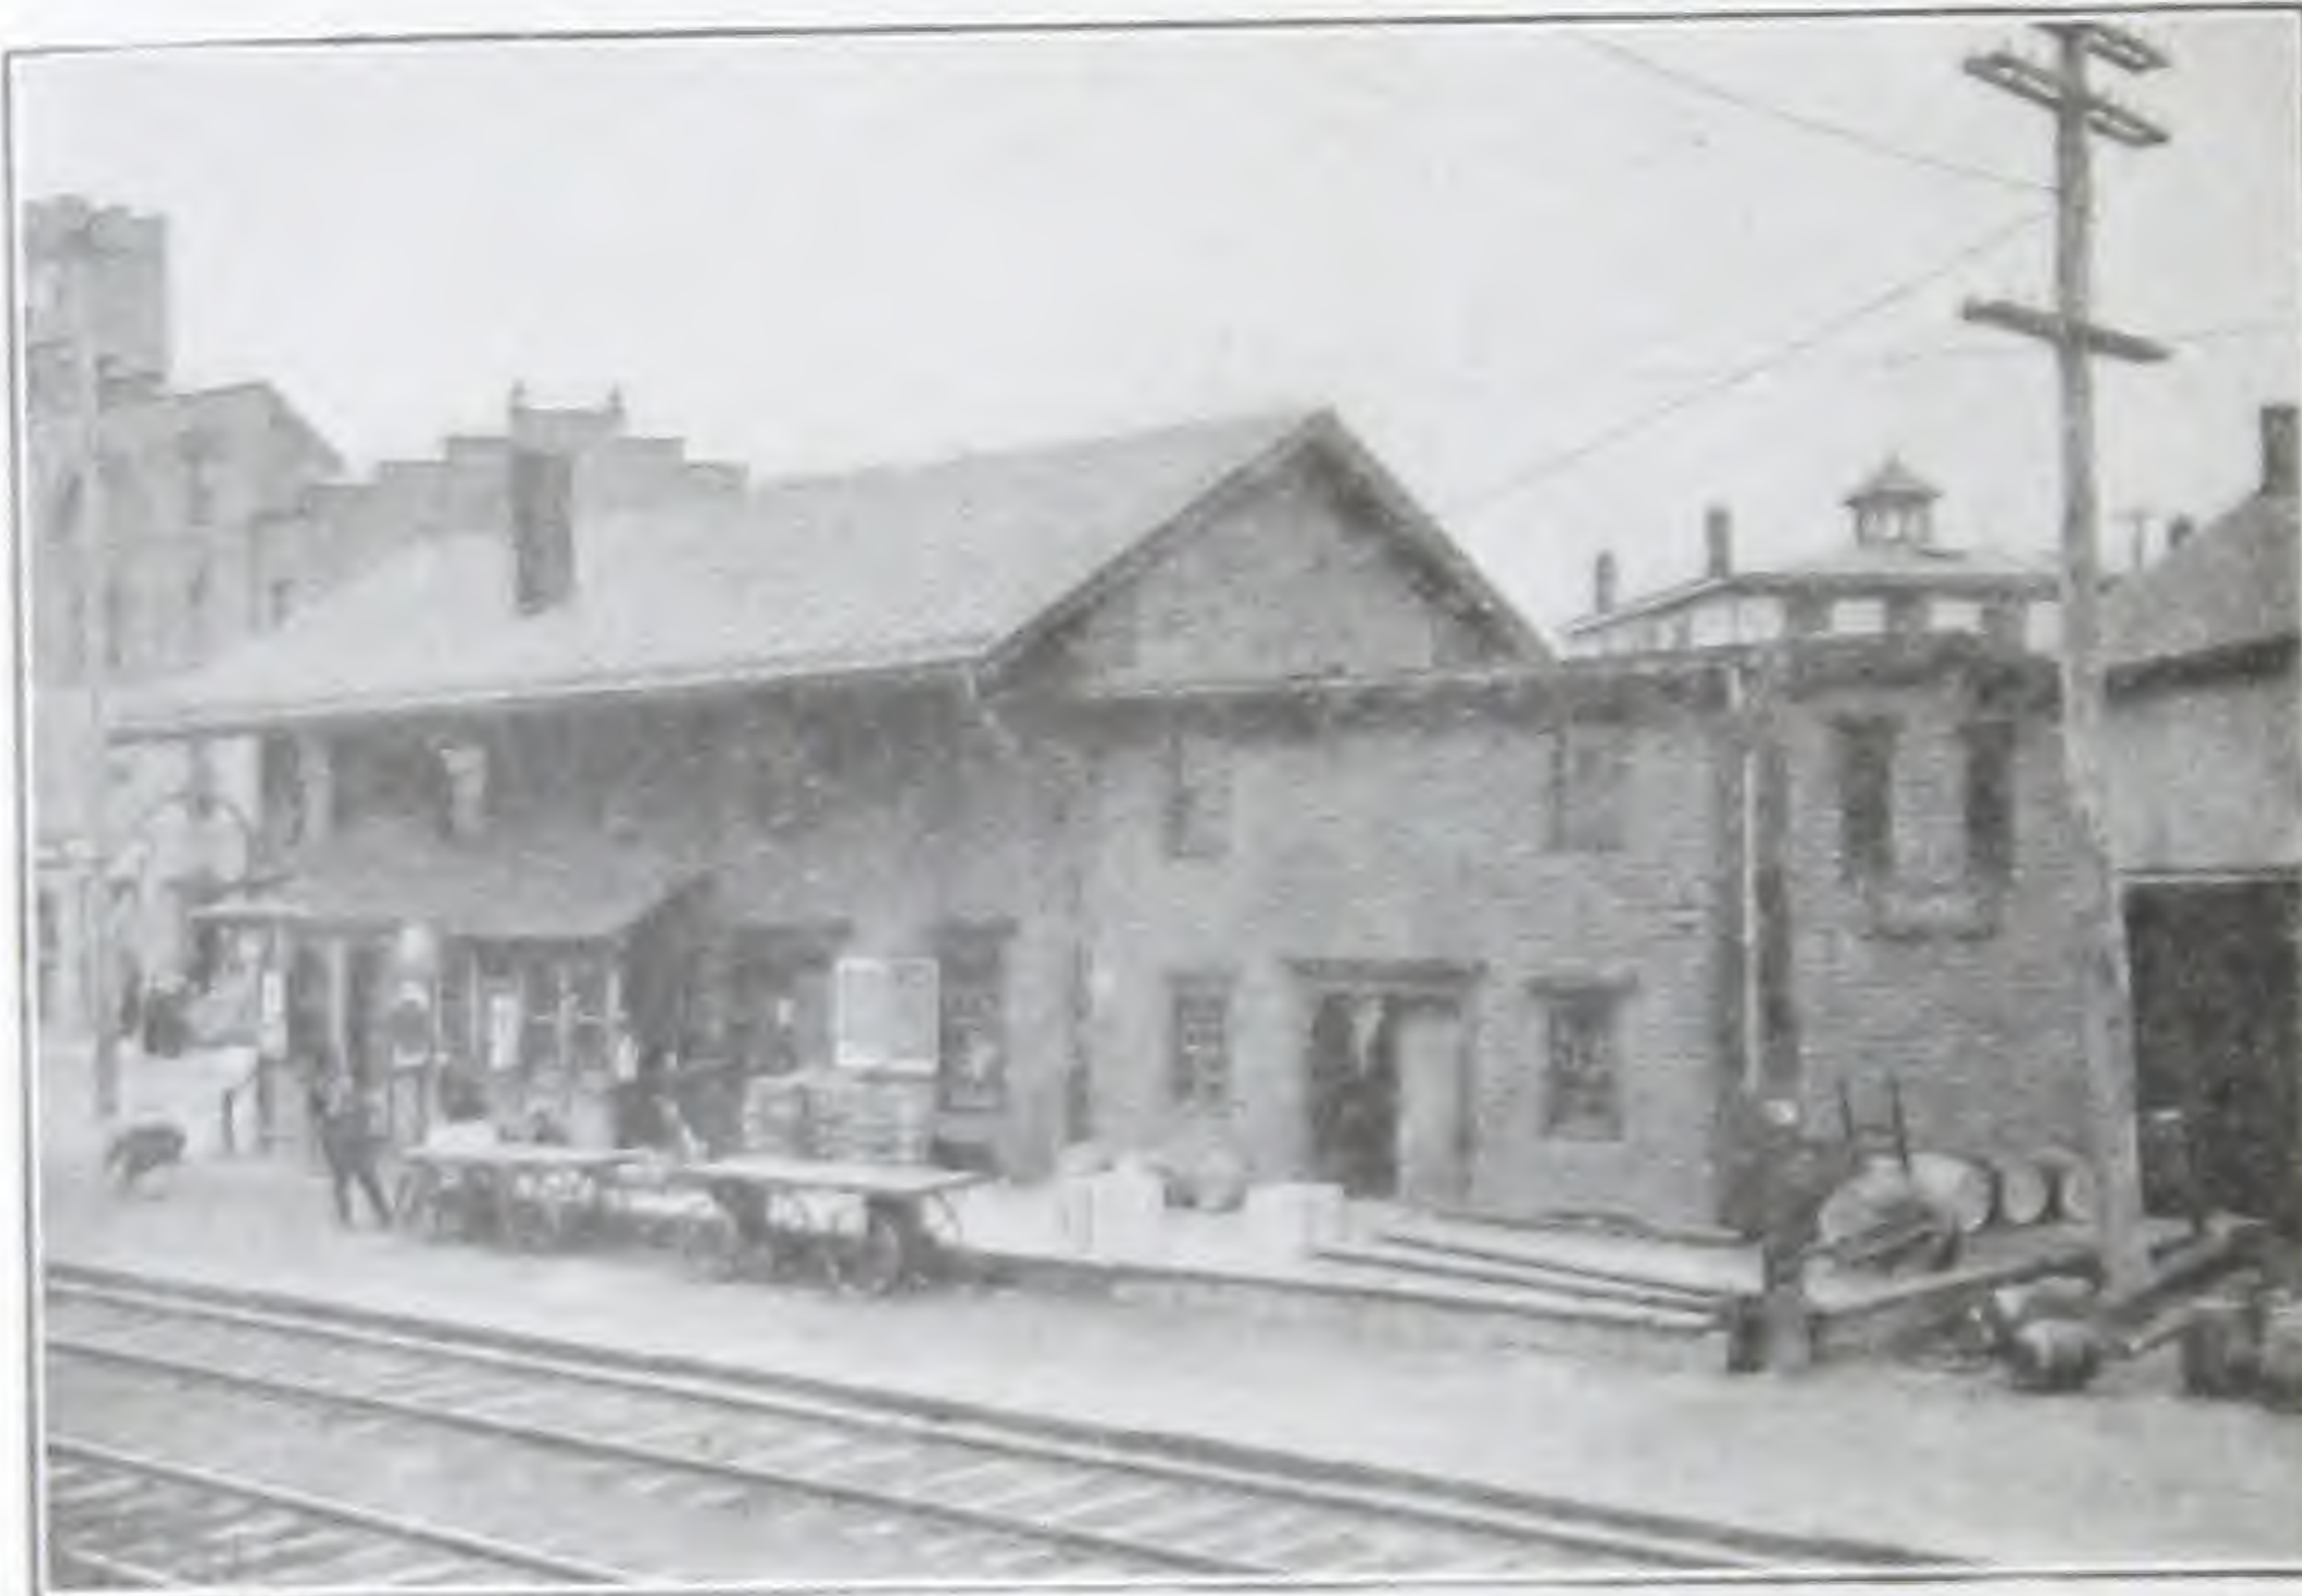
**9. DURABILITY:** This old station, on the line of the Erie Railroad at Monroe, N. Y., was roofed in 1847—*63 years ago*—with good tin. This roof stands to-day as a testimonial to the value of good tin roofing—unchanged by the wear and tear it has undergone, and apparently as good as when first put on the building.

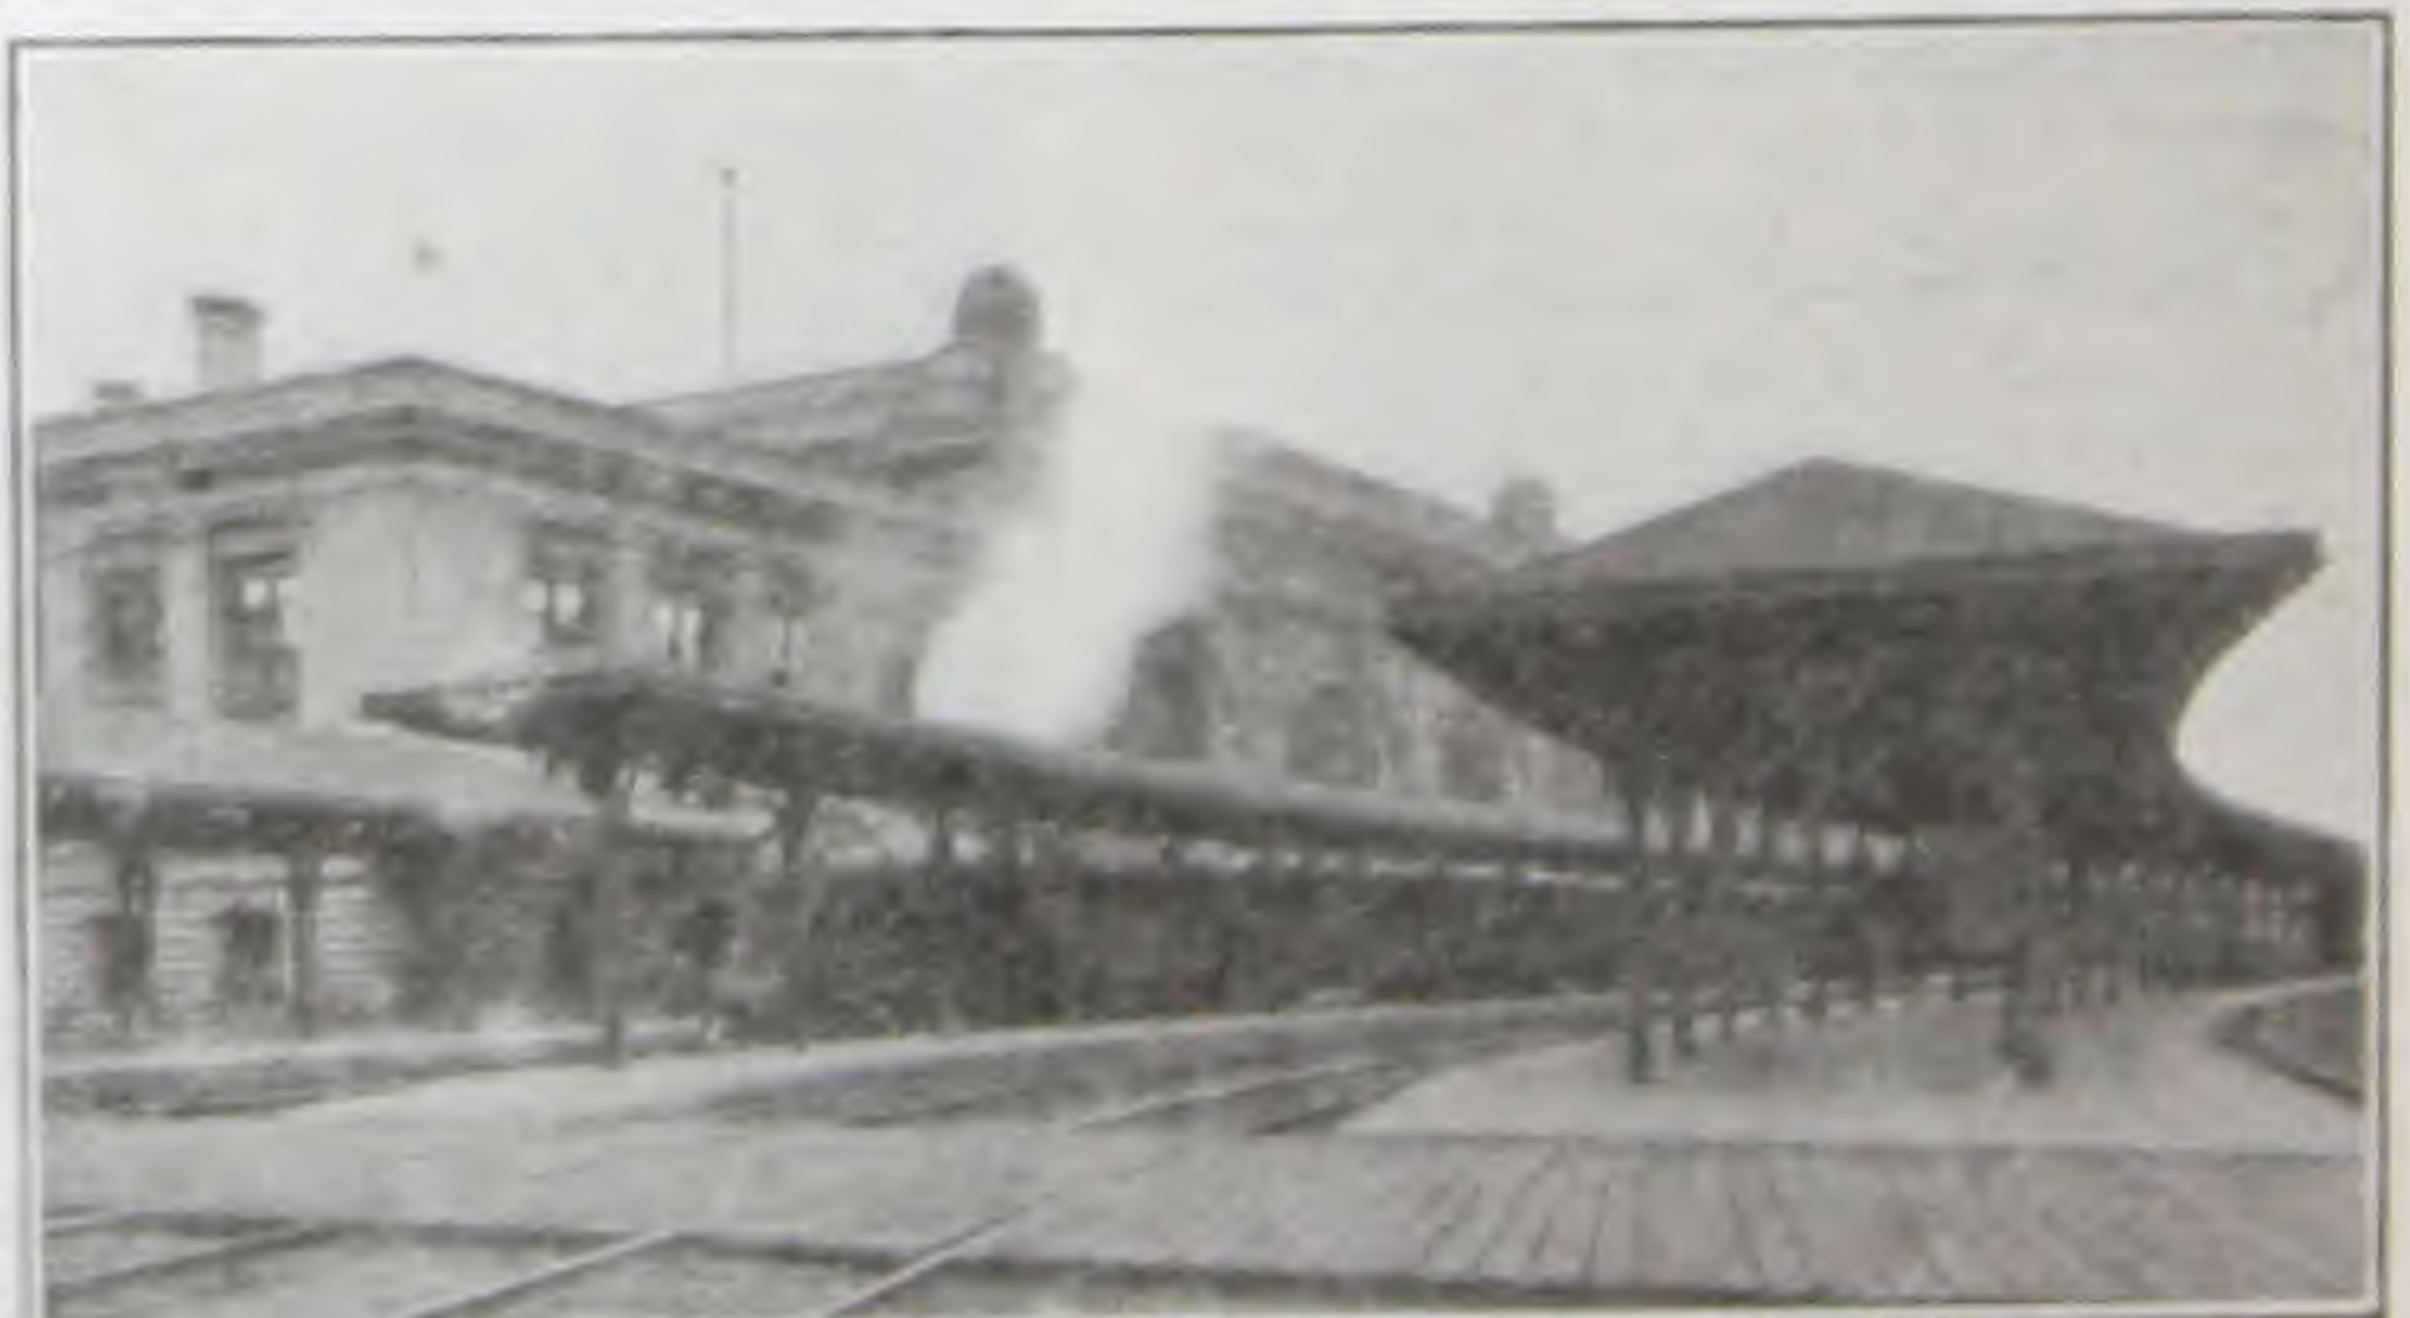
**10. DURABILITY:** The main building, platform sheds, etc., at Albany, N. Y., on the line of the N. Y. C. & H. R. R.R., were roofed with our tin in 1902. The chief engineer reports these roofs in first-rate condition after eight years' wear. This is mentioned merely as one of the innumerable cases that serve to show the durability of good tin roofs put on in recent years.

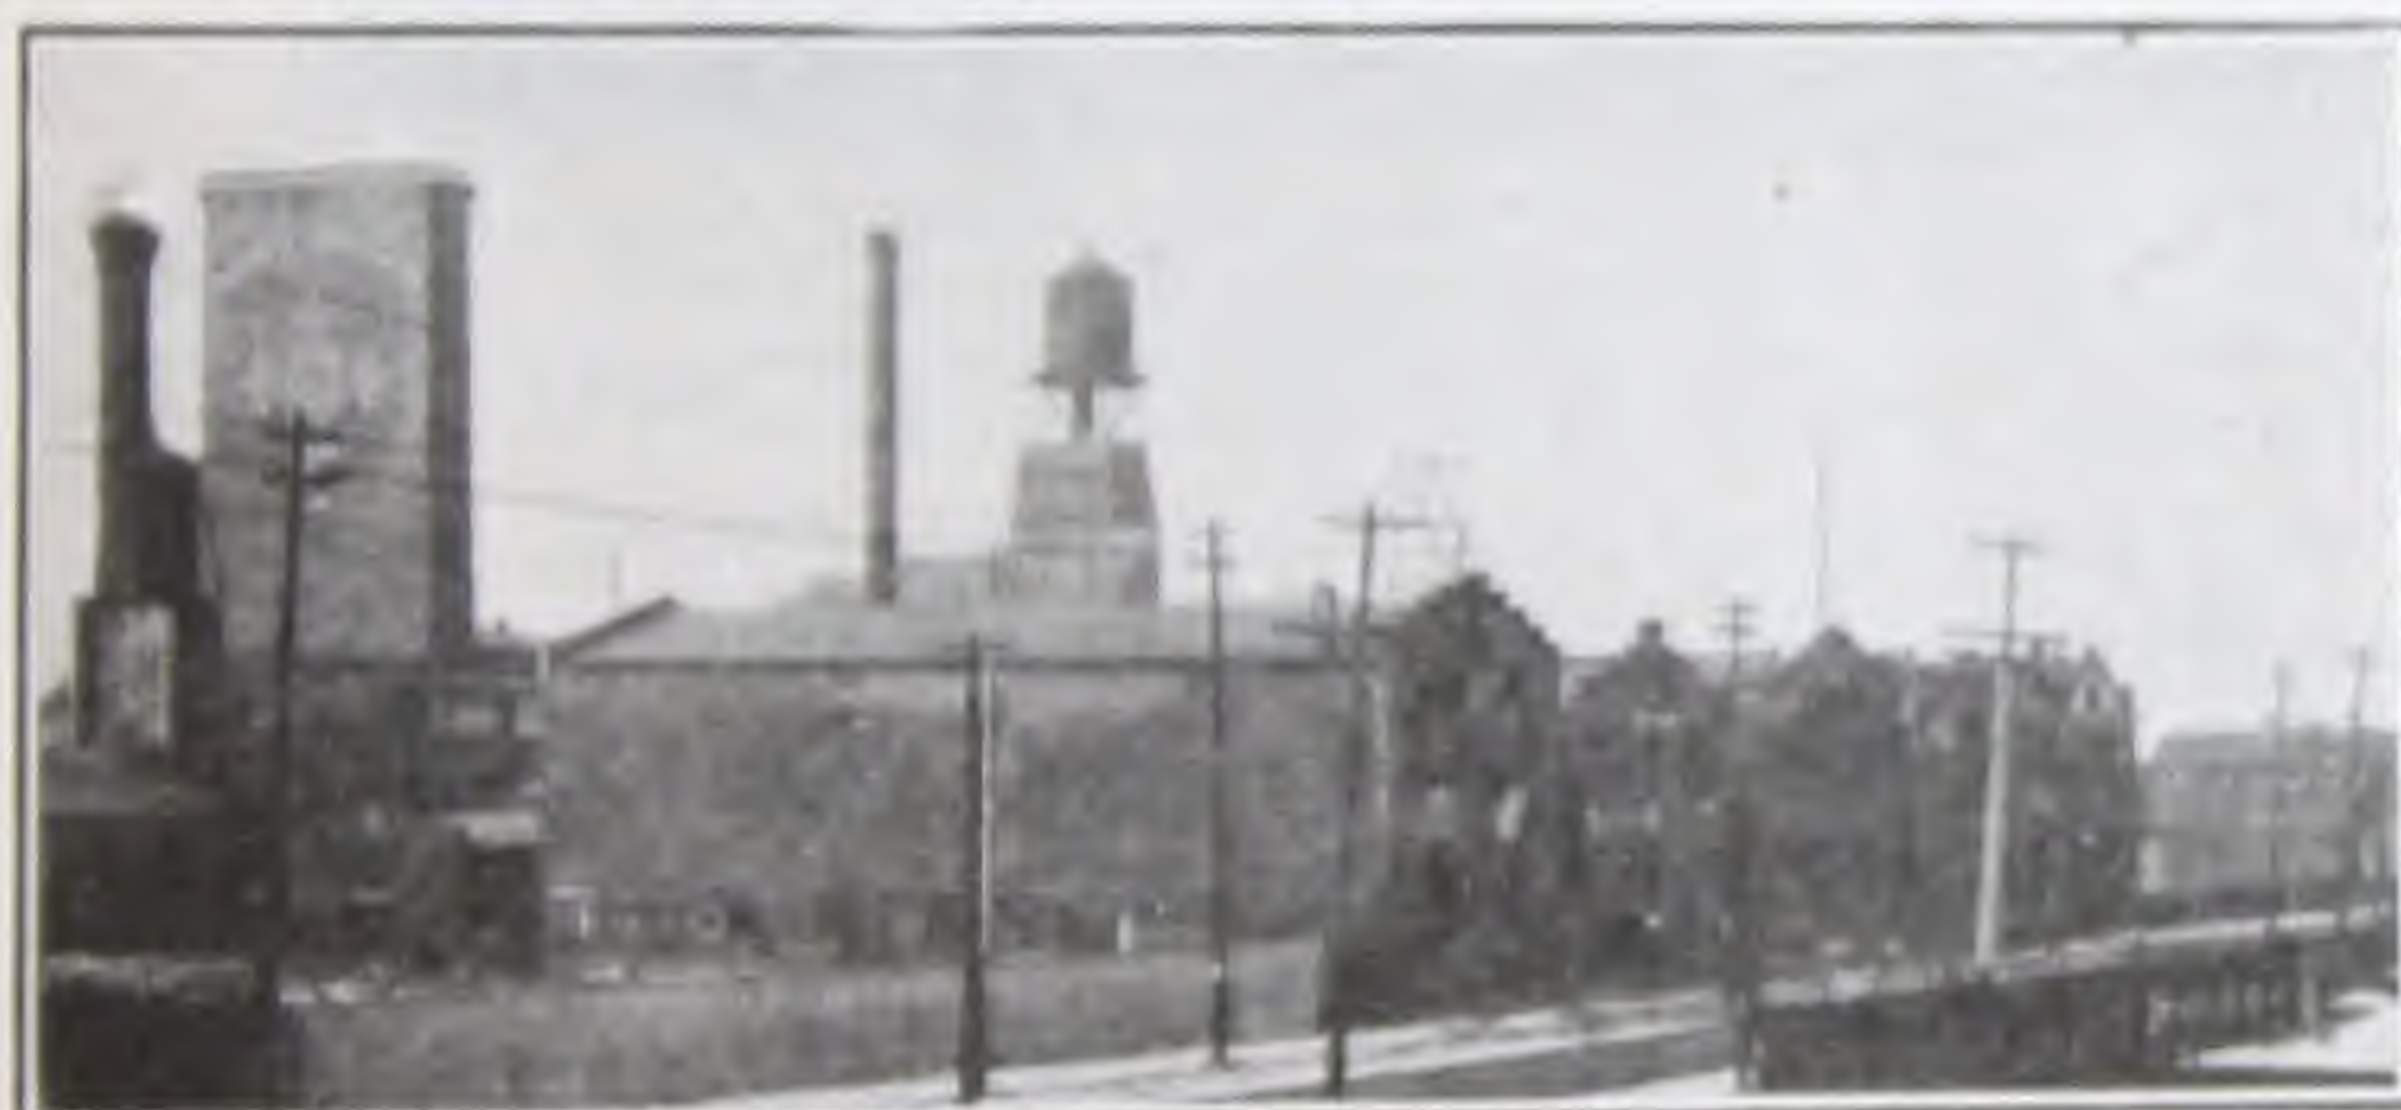
**12. DURABILITY:** Since 1887 to the present day our tin has been the standard for all roofing work on the permanent buildings of the Chicago Varnish Company. Additions were made in 1888, 1892, 1895, 1899, 1900, 1903, and 1905, requiring 22,500 sq. ft. of our roofing tin. The architects in charge of the construction work at this plant are enthusiastic over the satisfactory results secured from the use of this tin, and report that all the roofs are in excellent condition, although located in the midst of the manufacturing district and exposed to smoke from the numerous stacks and from locomotives constantly passing.
